**ARCHAEOLOGICAL SURVEY OF THE TUSCAN RIDGE MDP,
BEXAR COUNTY, TEXAS**

SWCA Project Number 10844-192-AUS
SWCA Cultural Resources Report No. 2006-95

March 7, 2006

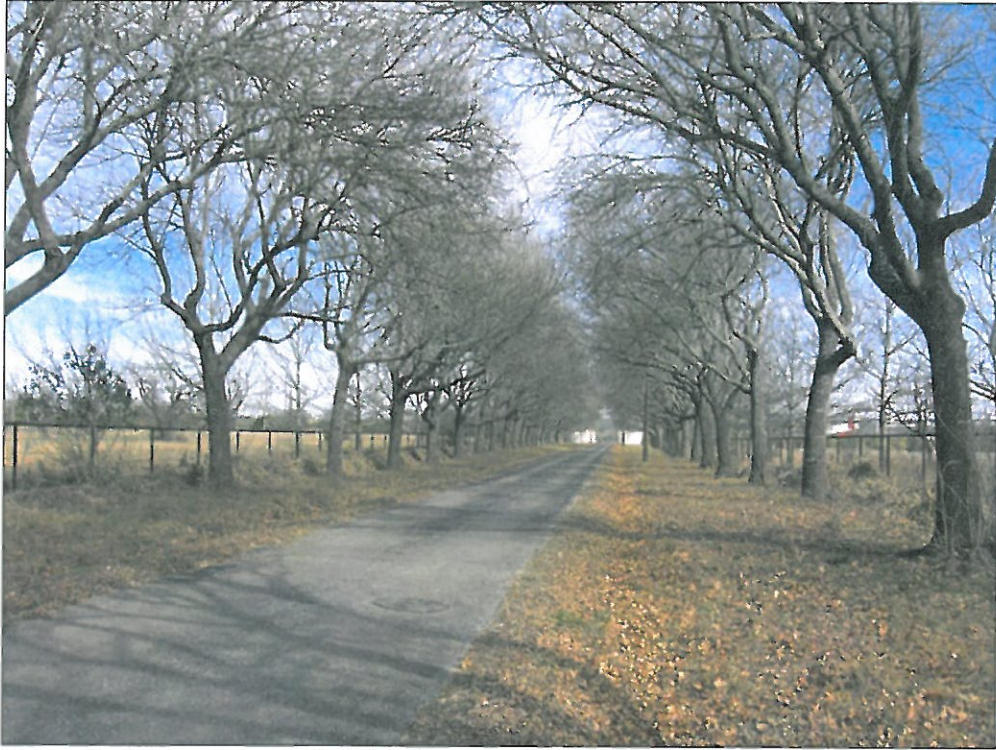
Figure 5. Live oak trees flanking the front drive. Note gate at end of drive.

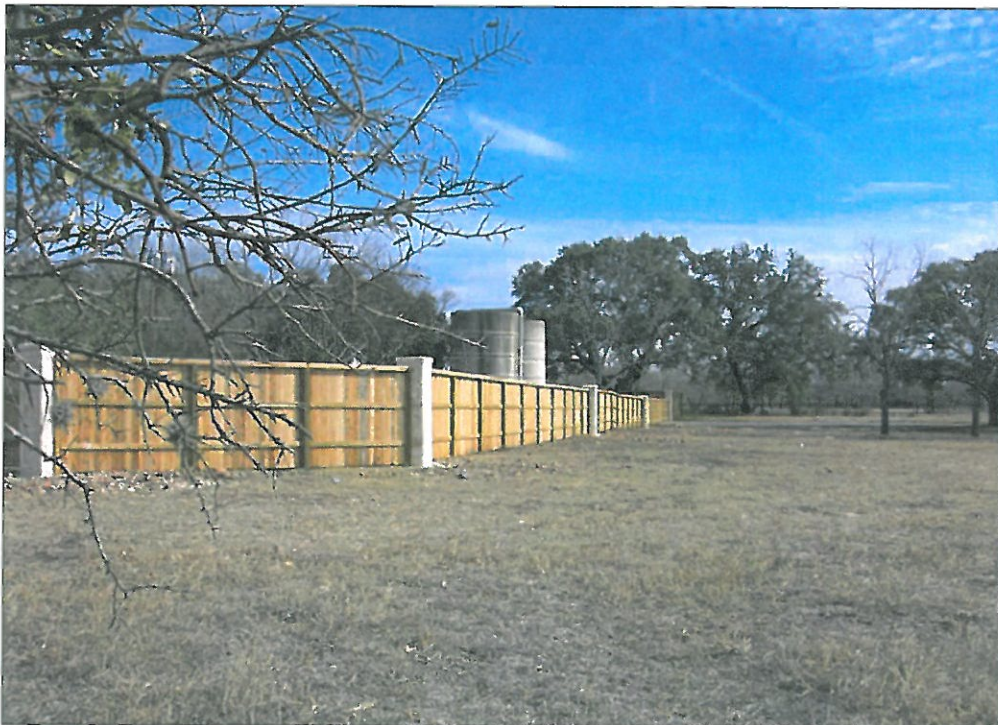
Figure 6. Brand new cedar fence and limestone support columns dividing the horse ranch complex.

A portion of the horse ranch complex has been divided from the rest and surrounded by a brand new cedar fence supported by limestone columns (Figure 6). This property is currently the primary residence of the former landowners, and was not surveyed. It has its own entrance, and several of the more modern residences are contained within the fence. It appears from a recent aerial photograph that a large barn or stable was dismantled prior to erecting the fence.

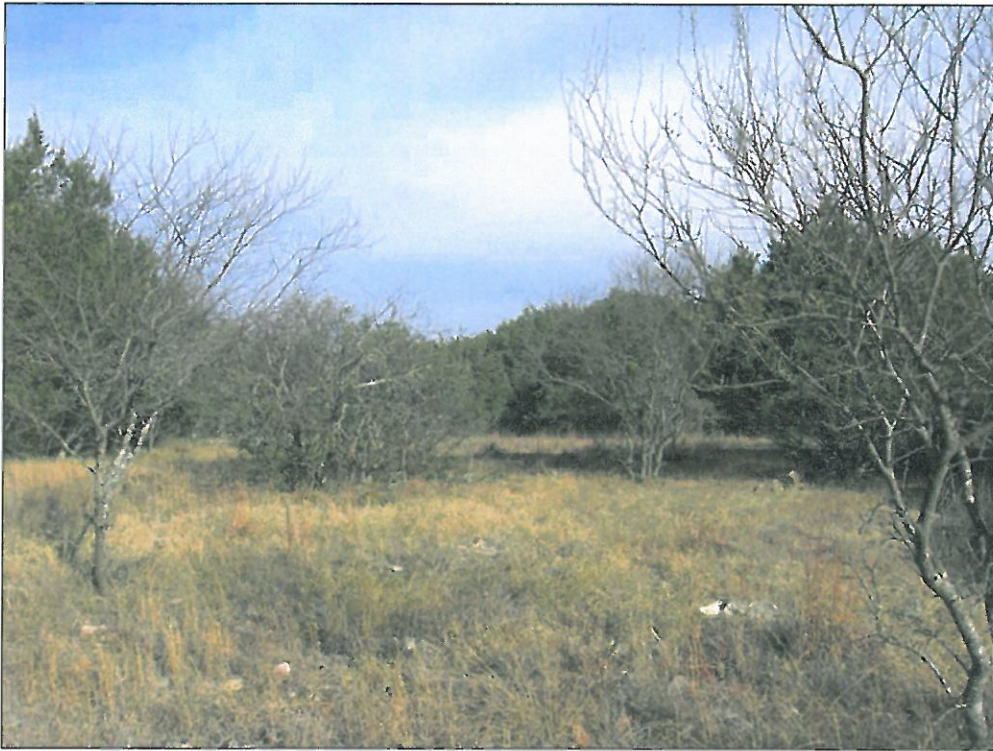
Figure 3. Typical vegetation found within the project area.

cacti, Spanish dagger, agarita, acacia, and greenbrier (Figure 3). The general topography of the project area consists of an upland ridge gently curving from the north to the southwest, with the land sloping downward on the eastern and western sides. The slopes are cut by several small dry upland drainages on either side of Bulverde Road that drain into East Elm Creek east of the project area (running north-south) and an unnamed drainage (running north-south) which empties into Elm Waterhole Creek around the rock quarry. Both East Elm Creek and Elm Waterhole Creek eventually join Mud Creek to the south.

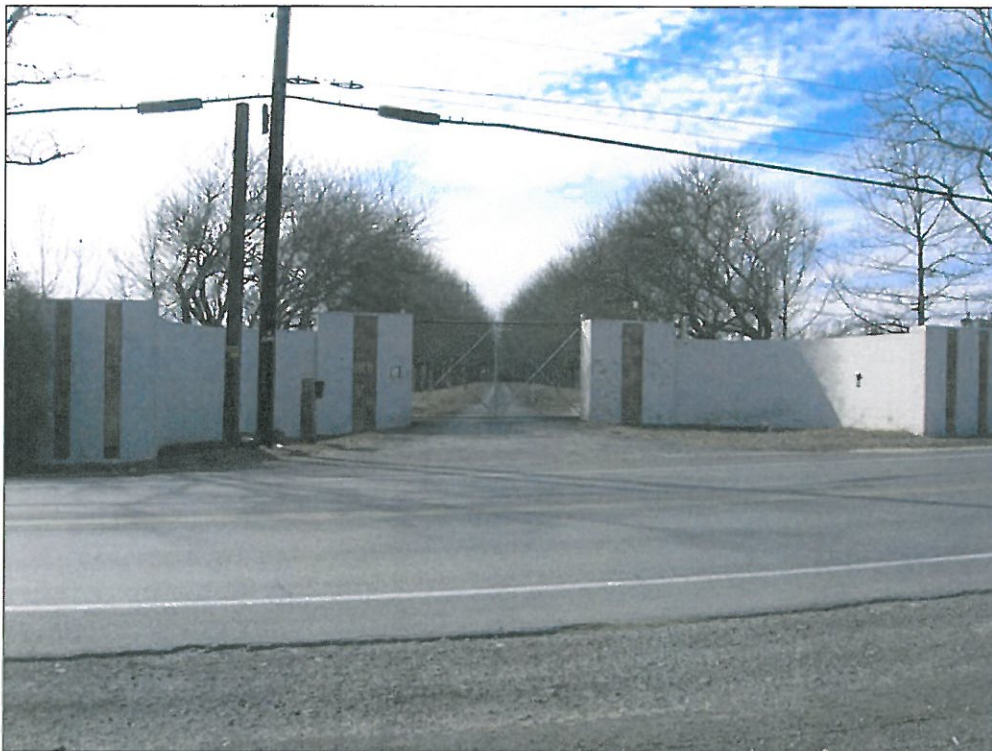
Figure 4. Front entrance to the project area.

Of note is the front entrance, which consists of decorative brick walls and columns on either side of an iron gate. The brick walls are bulky structures that span the distance between two brick columns on either side of the gate and curve away from the entrance towards the street. The brick walls and columns are covered with white paint, and inlaid with 12-x-12 Spanish red clay tiles (Figure 4). Behind the gate, a linear drive leads to the main residence (Building 1), flanked with mature live oak trees (Figure 5), reminiscent of a Southern Plantation entrance. The pasture fields are located on either side of the road.

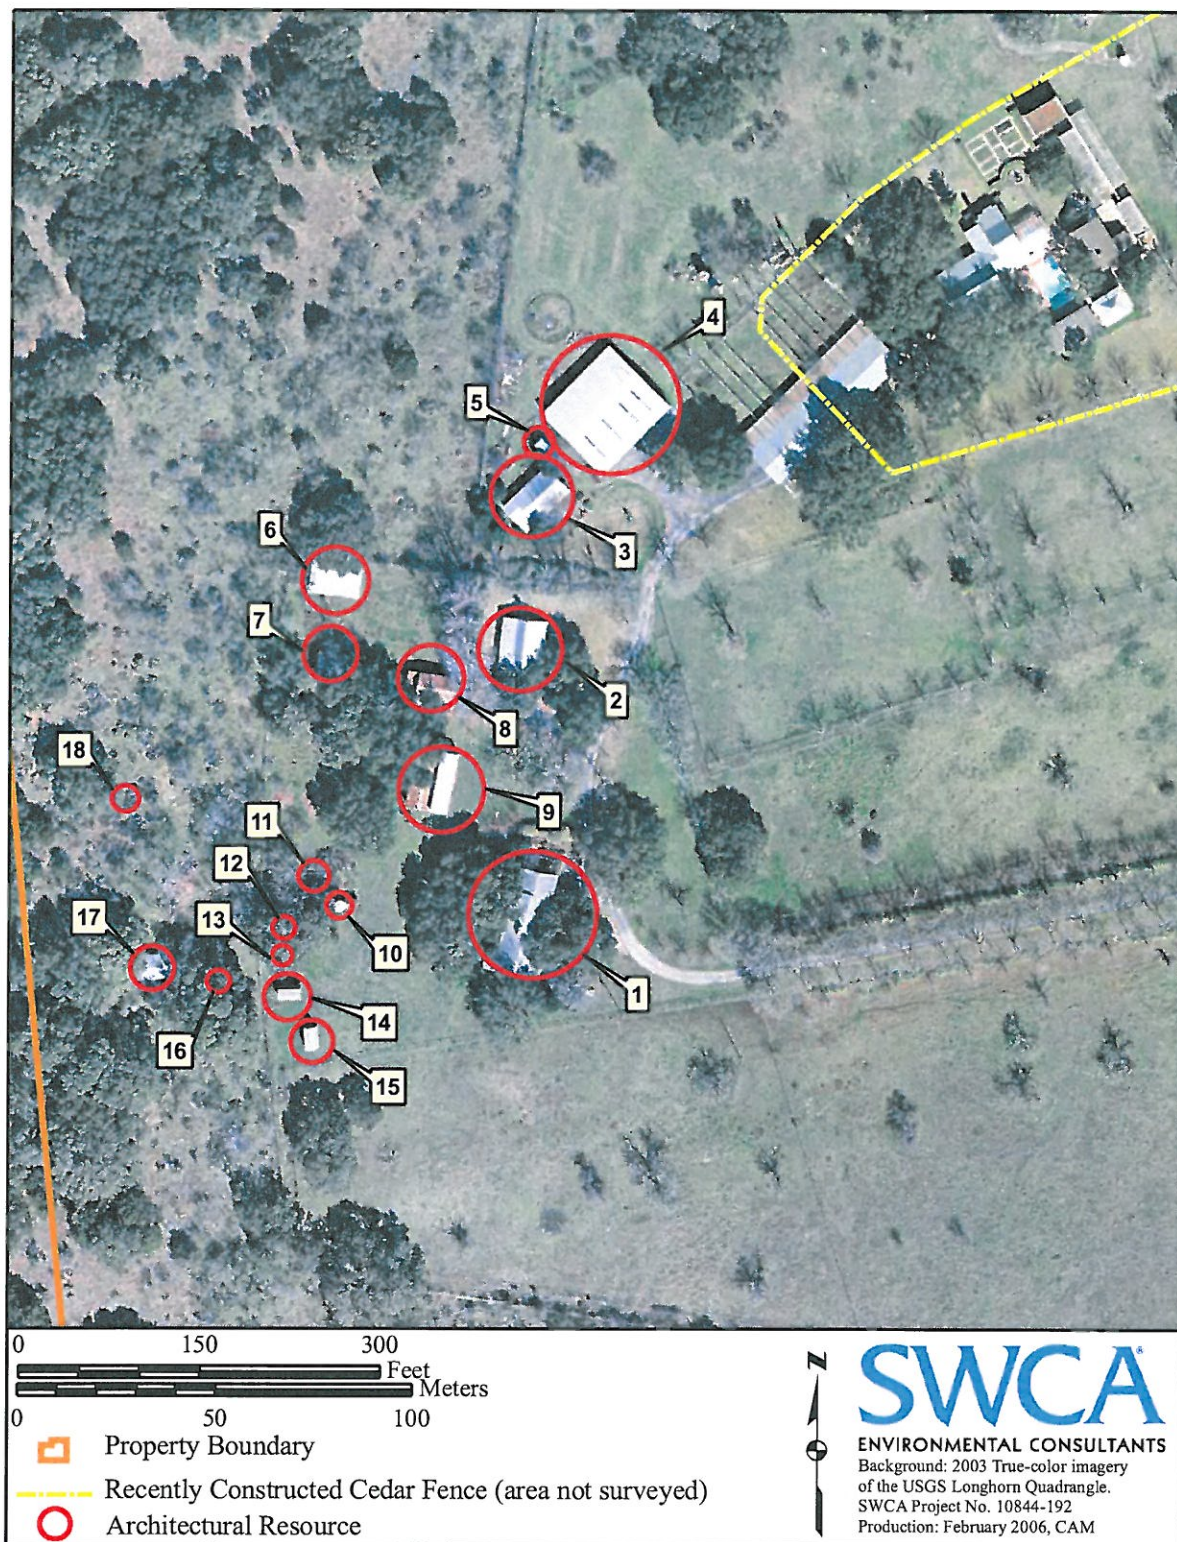
Figure 7. Aerial photograph of 18 architectural resources within the project area.

The disturbed areas within the Tuscan Ridge MDP were investigated with an architectural survey, which located 18 resources within the project area (Figure 7). Of the 18 resources, however, only one is certainly over 50 years of age, and one other has some features of a historic building, but is sheathed in modern materials. Descriptions of each resource are provided below.

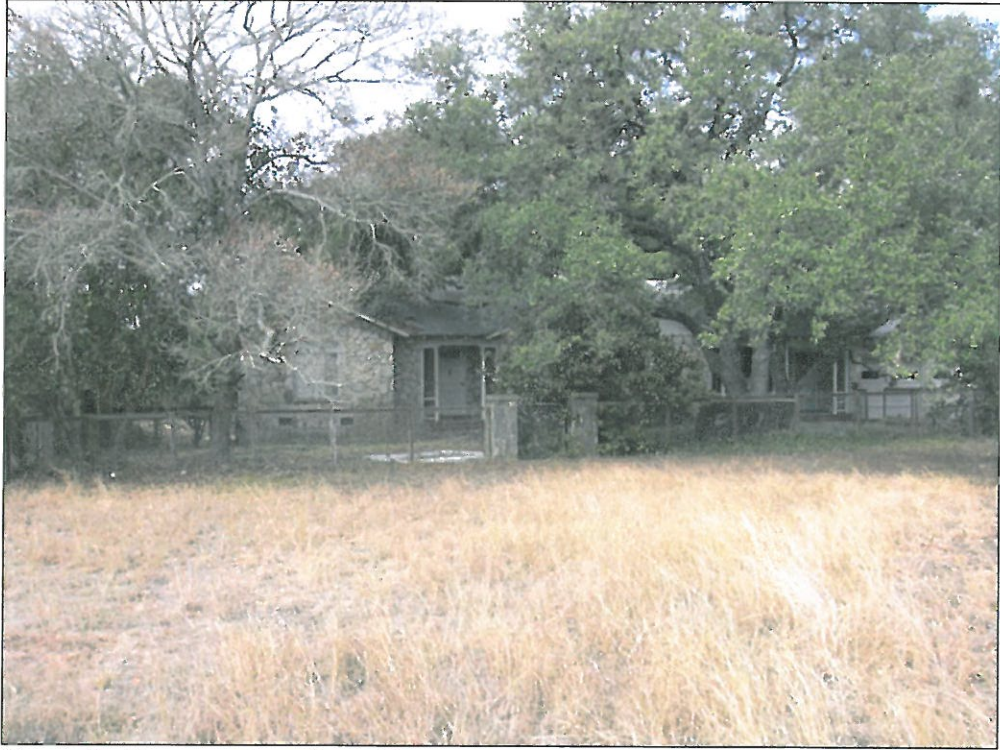
Figure 8. Resource 1, main residence.

Resource 1 is a single-family residence constructed of a single-story timber frame on a pier and beam foundation (Figure 8). The exterior is sheathed with irregular limestone blocks that have recently been repointed. The steel frame casement windows appear to be original to the house, and one front window contains a large picture-frame opening flanked by smaller steel frame casement windows (Figure 9). An attached garage large enough for two cars but containing two single car garage doors appears to be an addition to the north side of the house. Two front porches set into the house contain both a front door and another entry to the side. A cross-gable roof covers the house; the roof is predominantly a side gable, but punched with cross gables along the bumpouts on the south side of the house and over the picture window and an adjacent round window (Figure 10). The garage is covered with a side gable that matches with the original house on the front but is shorter at the back. The area surrounding the house has been heavily landscaped, containing a fenced-in front area with chain link and stone column supports, a chain link fence at the rear of the house, a stone fountain in the front yard, planting beds and ornamental trees to the north of the house, and a wooden fence surrounding a small area off the garage. The house appears to be the principle residence of the horse ranch, and the style and construction materials points to a 1935–1945 initial build

date with modifications made in the 1950s and the 1960s.

In sum, Resource 1 is of historic age, likely built around the late 1930s or early 1940s, and although Resource 2 is of a historic style, much of the building is too modern to consider it a historic resource. All of the other residences are less than 50 years of age. The bulk of the outbuildings directly associated with the horse ranch appear to be less than 50 years old as well, which would indicate that large-scale horse ranching was not this property's first operation. The age of many of the other outbuildings—the barns, water tank, sheds, and concrete structures, could not be determined. Of the resource that is of historic age, the overall integrity of the building has been diminished by modifications over the years, and the building no longer retains its original presence or footprint. Thus, the resource does not retain enough integrity to be significant.

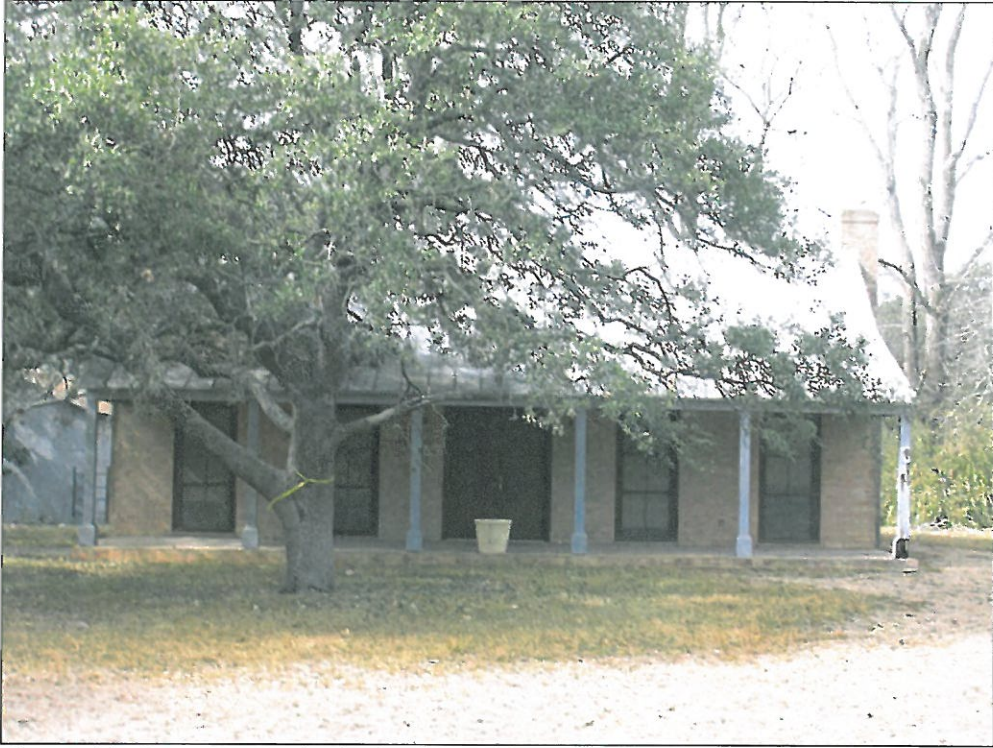
Figure 11. Resource 2, single-family residence.

Resource 2 is also a single-family residence. This house mirrors the classic form of an extended hall and parlor house of the coastal South (McAlester and McAlester 2004), which normally dates from the mid eighteenth century to the mid nineteenth century (Figure 11). The house contains two extended secondary roofs off the principal side gable, one fully enclosed and containing the kitchen and bathroom, and the other covering the front porch and supported by wood columns. Two large chimneys flank either side of the house (Figure 12). The windows, though unusually thin and tall for a residence, are wood frame double-hung sashes and placed symmetrically around the front door. Despite the antique form however, the construction materials indicate the house is much more modern. The structure is placed on a concrete foundation, the exterior is sheathed with rolled-edge pink face brick in a standard running bond, and the roof the covered with new galvanized steel V-groove sheets and trimmed with hardboard (Figure 13). A peek through the windows indicates the interior has modern outlets and a layout in a 1970s style. Although the exact age of the shell cannot be determined, all of the building materials indicate a late twentieth century construction.

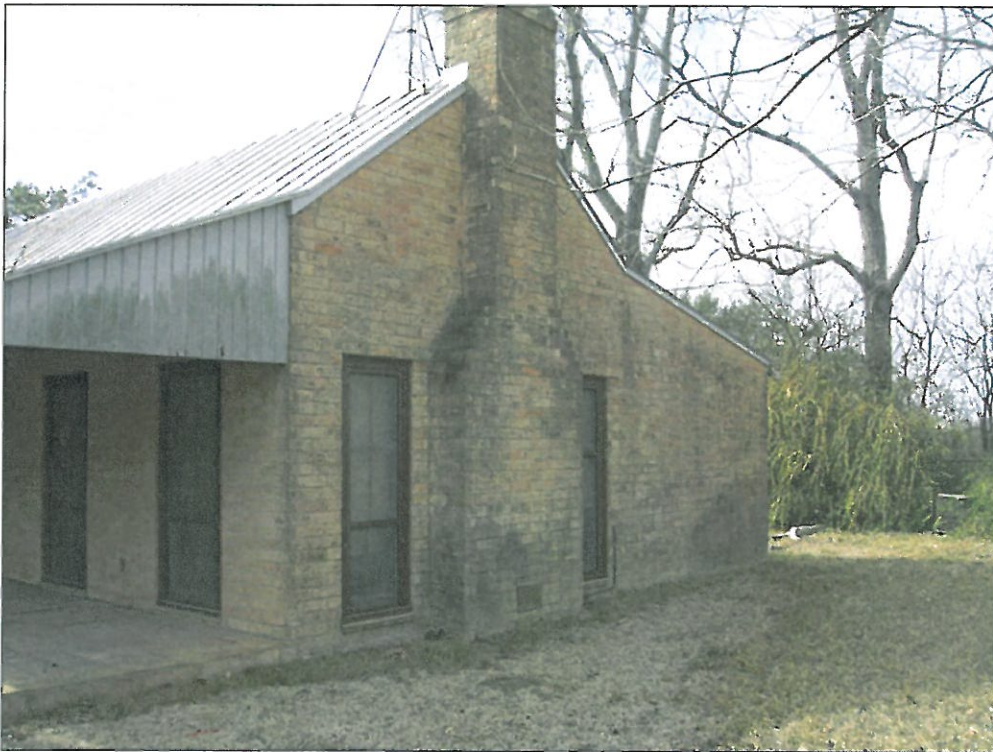
Figure 13. North side of Resource 2, showing brick, roof, and hardboard siding.

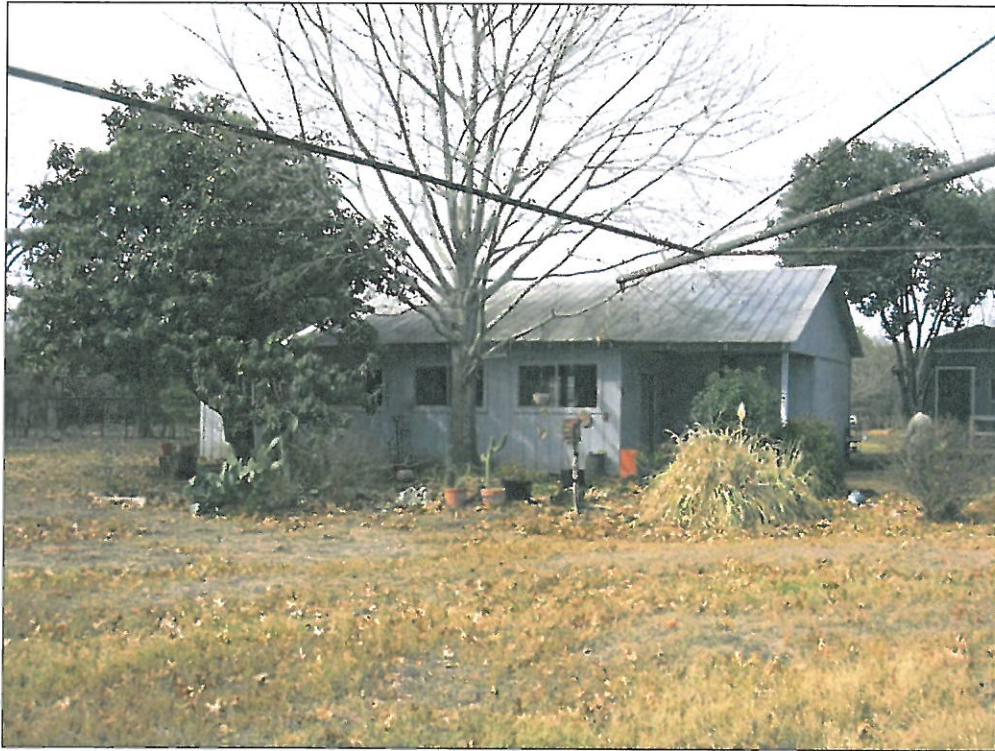
Figure 14. Resource 3, single-family residence.

Resource 3, another single-family residence in the project area, and looks to be a modern rectangular single-story timber frame structure on a concrete foundation (Figure 14). It is sheathed with painted hardboard, and the side gable roof is covered with V-groove galvanized steel sheets. The windows are single-pane sliding windows with aluminum frames. A covered porch is located at the northeast corner of the building, where the front door is placed. The overall size of the building is 47 feet wide by 24 feet long. The building does

not contain any elements that are older than 50 years.

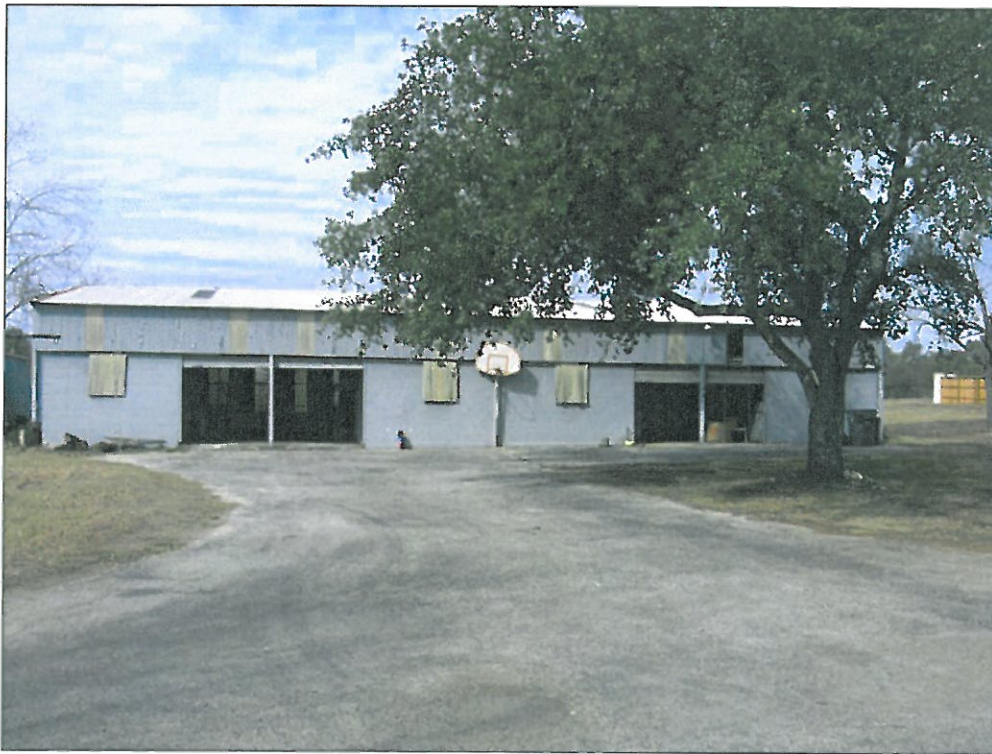
Figure 15. Resource 4, large horse stable.

Resource 4, the largest building in the project area, is a horse stable (Figure 15). It is built with a metal frame superstructure covered with corrugated galvanized steel sheets. The horse stalls are constructed with concrete blocks, some of which make portions of the exterior wall, and the side gable roof is covered with corrugated galvanized steel sheets. A shed-roofed addition is attached to the back of the building, also covered in similar materials (Figure 16). The stable openings consist of garage doors, and several openings were seen in the shed addition. No glass windows were observed, but several rough openings in the building were covered with plywood that could be slid open to let in air. The overall size of the building is approximately 90 feet wide by 64 feet long.

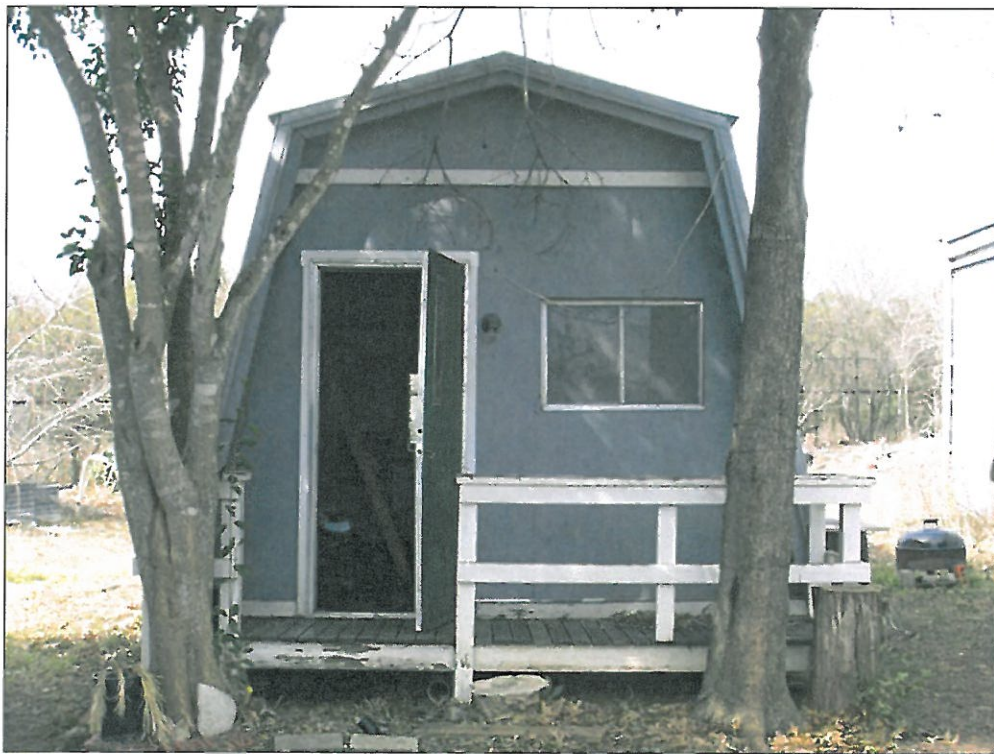
Figure 17. Resource 5, portable cabin.

Resources 5, 12, 13, 14, and 15 are all similar buildings, and will be discussed as a group. Each building is a portable cabin, likely to be used by a single occupant. Resource 5 is the most intact of the five buildings, and contains a front façade with an aluminum frame window, steel exterior door, and a porch (Figure 17). The other four buildings either have only a plywood panel door or no door at all (Figure 18). All of the buildings sit on concrete blocks, are covered with plywood and particleboard sheets, and have a gambrel roof reaching to the ground and sheathed in new V-groove galvanized steel sheets. PVC plumbing can be seen under each building, but none are attached to any water or wastewater system. Resources 12 and 13 are in a particularly advanced state of decay. The size of each building is 12 feet wide by 19 feet long, and the porch on Resource 5 is 12 feet wide by 4 feet deep.

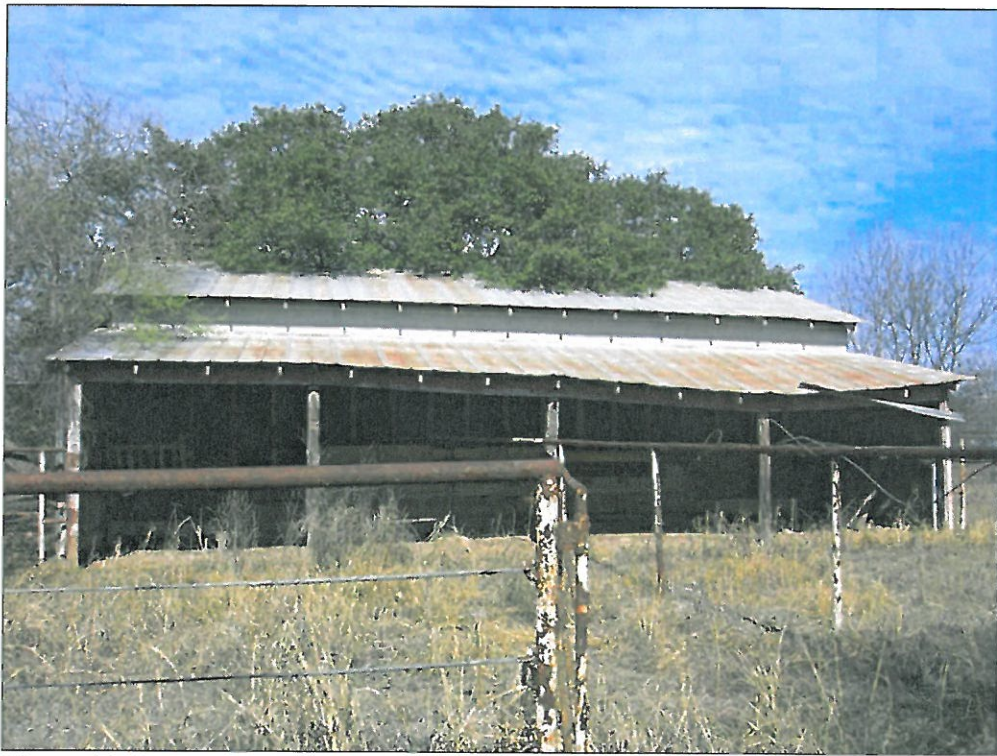
Figure 19. Resource 6, small barn.

Resource 6 is a barn to house small or mid-size domesticated animals. It is a wood frame

building set on concrete forms with a side gable roof and shed addition to the front (Figure 19). The front of the shed addition is open and supported by cedar posts. The top and sides of the building are sheathed with V-groove galvanized steel sheets. The overall size of the building is approximately 30 x 40 feet.

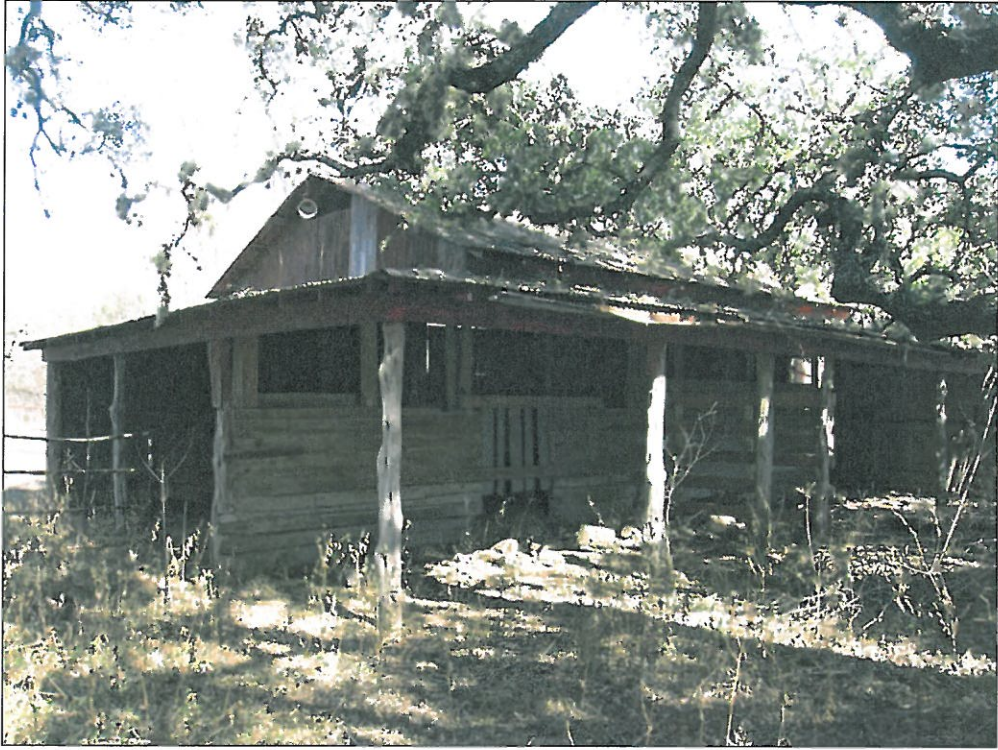
Figure 20. Resource 8, birthing stable.

Resource 8 is also a horse stable, but the extra large stalls and small overall number in the building ($n=2$) indicates this was possibly a birthing stable. This stable is located closer to the residential structures than the large horse stable, perhaps so the residents could keep a close eye on the proceedings. The building is a timber frame structure on a concrete foundation with a gable roof and a wrap-around shed addition supported by cedar posts (Figure 20). The interior stalls are wrapped with wooden planks and the roof of both the gable and shed addition comprises corrugated galvanized steel sheets. Hoppers for storing hay are located along one wall and inside. The overall size is 35 x 28 feet.

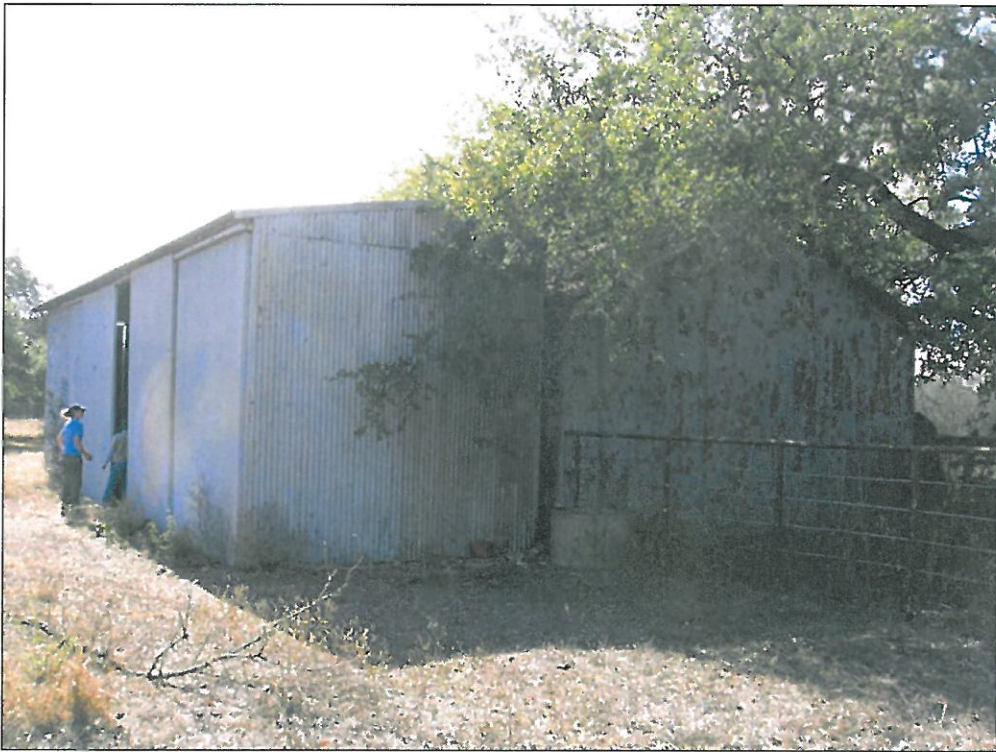
Figure 21. Resource 9, barn.

Resource 9 is another barn, likely used to store heavy machinery and equipment. The barn consists of an older rectangular building constructed of timber frame on a concrete foundation and sheathed in V-groove galvanized steel sheets. The exterior appeared to have been painted; the paint is currently peeling off (Figure 21). Later, one side of this building was opened up, and another rectangular building was constructed adjacent to the existing building and attached. The newer structure is

built with a steel frame, and covered with corrugated galvanized steel sheets. The building is shed roofed, and had one large sliding door also covered in galvanized steel sheets. One door and one window opening were seen in the older building. The overall size of the building is 50 feet long by 35 feet wide.

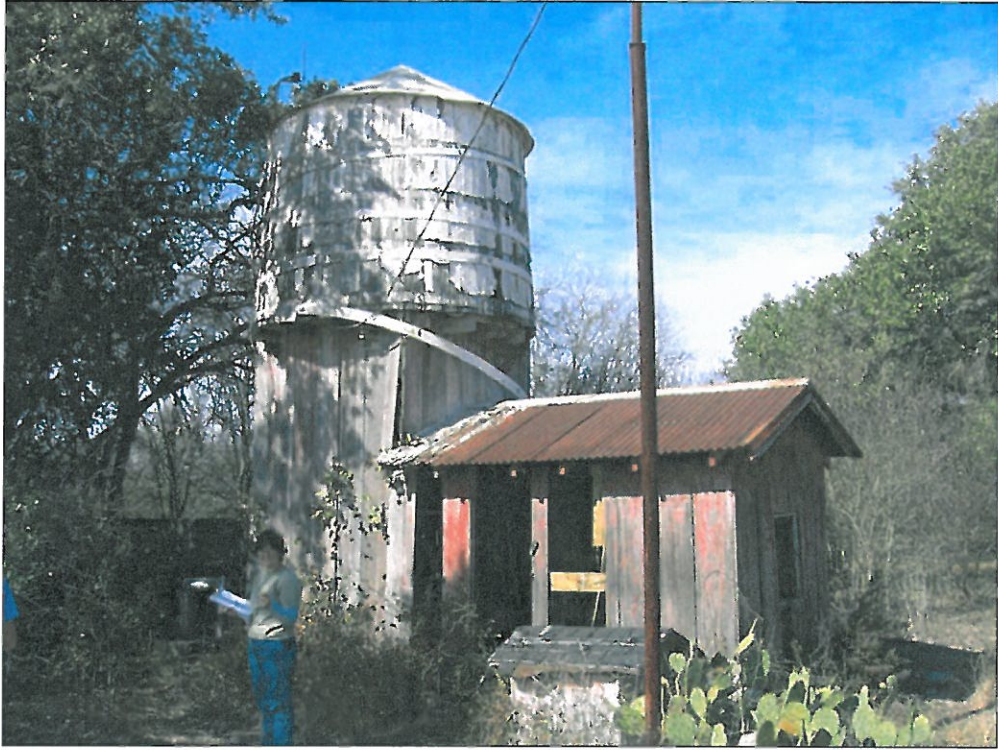
Figure 22. Resource 10, water tank and equipment shed.

Resource 10 is a water tank and equipment storage shed. The water tank is a circular wooden tank with metal straps and a conical galvanized steel roof, sitting on a wooden platform and supported by a steel frame. Around the steel frame, wooden plank walls were constructed to cover the electrical boxes and pumping equipment under the tank, and an addition was attached consisting of a wood frame building set on a concrete pad, wood plank walls, and a gable roof covered in corrugated galvanized steel sheets (Figure 22). Several planks are missing from the building, and the water tank and equipment does not appear to be operational. The footprint of the building is 6 x 20 feet.

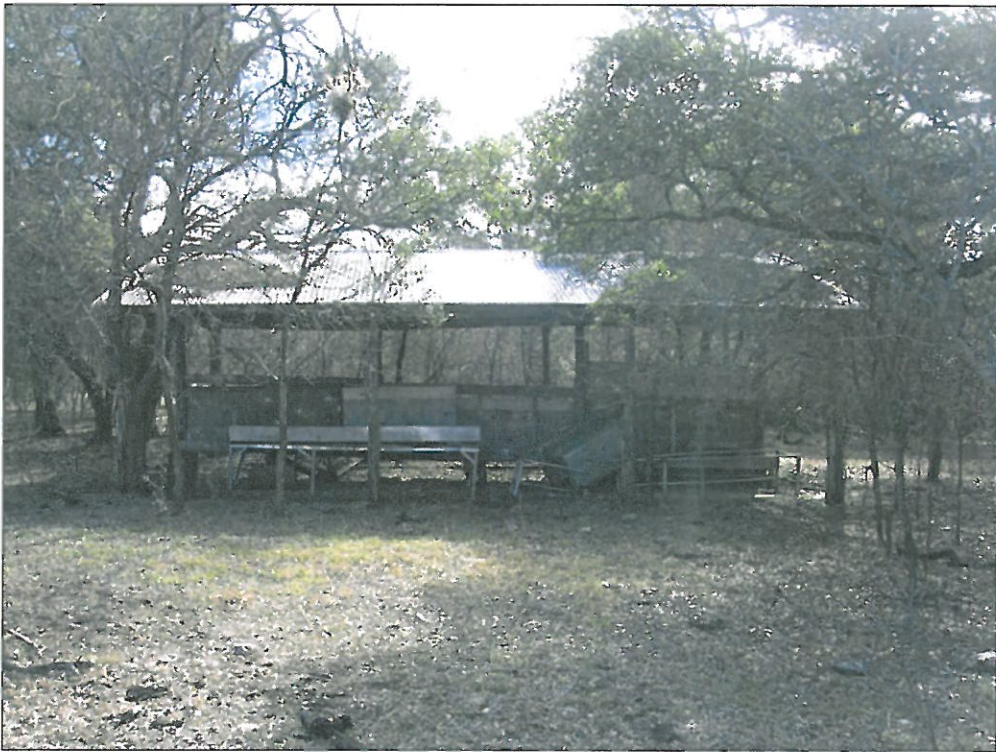
Figure 23. Resource 17, open sided shed.

Resource 17 is an open-sided shed, made with cedar posts set into the ground, a wood frame rafter system, and a corrugated galvanized steel roof. This roof covers an unusual setup of large shallow galvanized steel sinks set on platforms, with drain holes at the bottom, and one large and deep cast stainless steel sink tipped on its side (Figure 23). The operation

seems to be some sort of washing procedure, but what was being processed is unknown. Only small gravels were seen in the sinks. The building size is 35 x 22 feet.

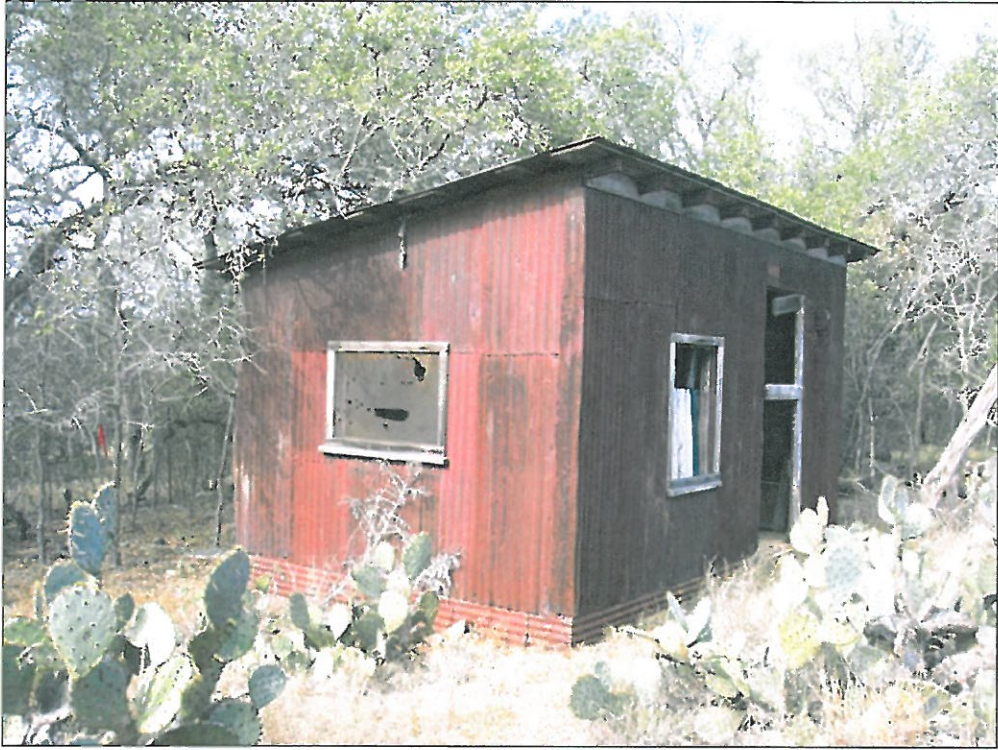
Figure 24. Resource 18, small shack.

Resource 18 is a small shack set apart from the rest of the complex. It is a wood frame building set on a concrete pad, covered with weathered corrugated galvanized steel sheets, and a shed roof (Figure 24). One door opening and three window openings were seen, but no glass was visible in the window frames. Wooden planks covered the walls on the interior, and were covered with graffiti in Spanish. The building size is 10 x 16 feet.
